Sony Service Company - Technical Services  
A Division of Sony Corporation of America  
Sony Drive, Park Ridge, New Jersey 07656

**Model:** All CDP/CDP-C

**No.** 286R1

**Subject:** Will Not Play Disc / Skips After Optical Block Replacement

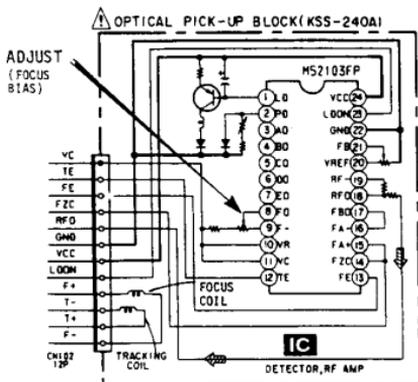
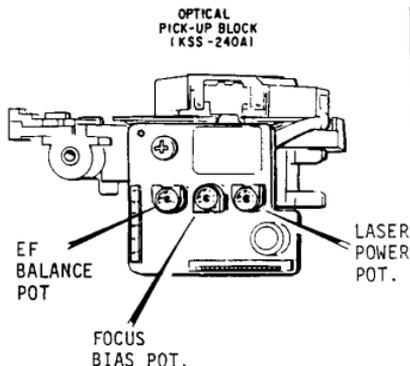
Clear RF signal waveform means that the shape "◇" can be clearly distinguished at the center of the waveform.

Focus Bias is out of adjustment. Adjust focus bias pot on optical block KSS-240A as follows:

1. Use a YEDS-18 disc.
2. Adjust the focus bias pot for the clearest eye pattern.
